# Analysis of shaft alignment on vibration and motor power consumption in cooling water pumps

## 2. Methods

The research was conducted at PT Nusantara Power Unit Pembangkit Pekanbaru, specifically at the Koto Panjang Hydroelectric Power Plant service unit, located on Bangkinang – Jalan Payakumbuh, Merangin Village, Kuok District, Kampar Regency, Riau Province. The experimental object of this research was a cooling water pump driven by an IEC 60034 motor with a rated power of 45 kW. The primary instruments used in this study included an SKF Shaft Laser Alignment Tool TKSA 51 for alignment measurement, a vibration meter for monitoring dynamic responses, and an electrical measuring device for recording current and voltage to estimate motor power consumption.

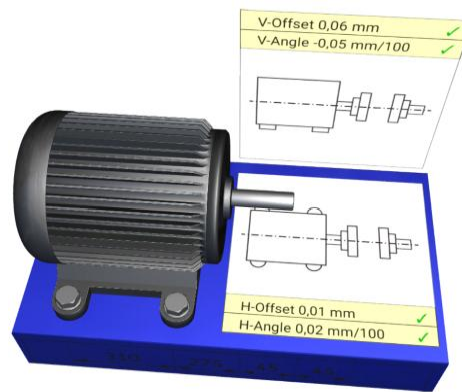
Figure 3. Measurement results after repairs

The shaft alignment measurement was conducted to ensure the conformity of the position and angle between the motor and the components installed in the assembly, as illustrated in Figure 3. The main parameters measured include vertical offset (V-Offset), horizontal offset (H-Offset), as well as vertical angular deviation (V-Angle) and horizontal angular deviation (H-Angle). The measurement results after the alignment correction are shown in Table 4.

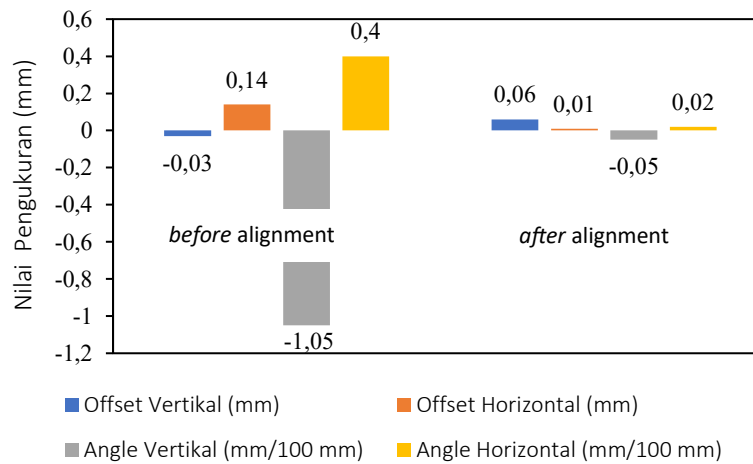
*Figure 4. Histogram before and after shaft alignment*

The graph above explains the condition of misalignment and the condition after corrective shaft alignment was performed. The measurement values before correction showed considerable variation, especially in the angular error parameters (vertical and horizontal angles) with values of -1.05 mm/100 mm and 0.4 mm/100 mm, respectively, compared to the tolerance value of 0.08 mm/100 mm. After correction, the vertical angle changed by 1 mm to -0.05 mm/100 mm. The horizontal angle decreased by 0.38 mm from 0.4 mm/100 mm to 0.02 mm/100 mm. The relatively flat orange line close to the zero axis

in the graph indicates that the correction successfully stabilized the position and angle of the shaft effectively.

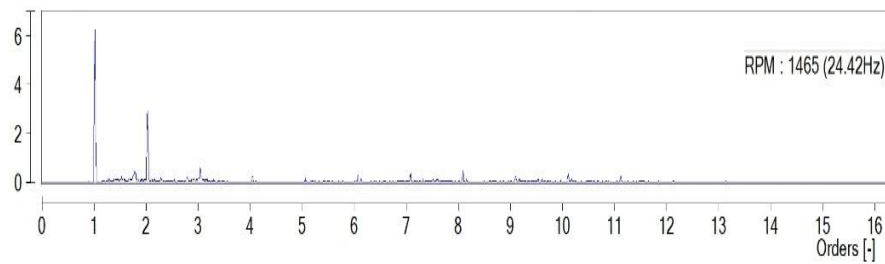
Figure 6. Horizontal DE Motor Vibration Spectrum

In the horizontal spectrum, in Figure 6, strong amplitudes at the  $1\times$  and  $2\times$  running frequencies reflect coupling forces induced by misalignment. The vertical spectrum, in Figure 7, shows similar harmonic components but with lower amplitude compared to the horizontal direction, suggesting uneven load distribution across the motor bearings. The

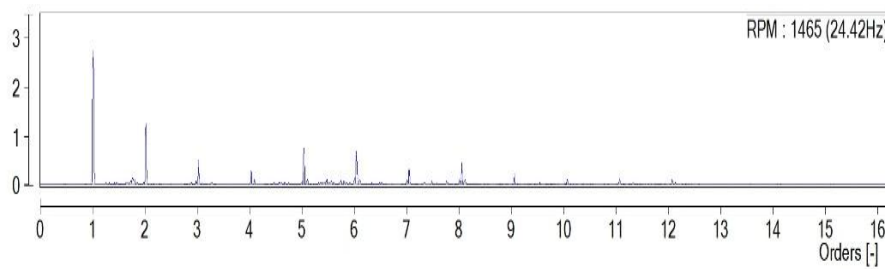
Figure 7. Vertical DE Motor Vibration Spectrum

Figures 6 to 8 present the vibration spectrum of the motor drive end (DE) in the horizontal, vertical, and axial directions at 1465 RPM (24.42 Hz). The spectra clearly reveal dominant peaks at the fundamental running frequency and its harmonics. These patterns are characteristic indicators of shaft misalignment, particularly angular misalignment, which typically generates significant vibration components in both axial and radial directions.

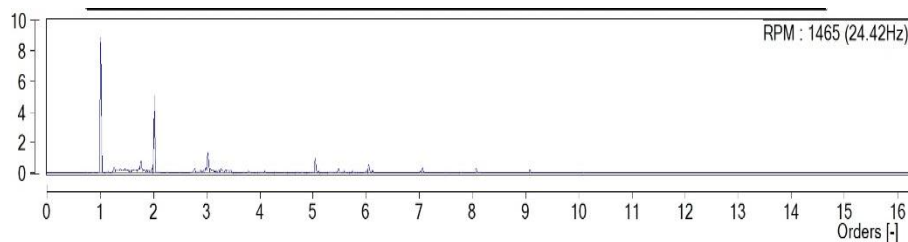
Figure 8. Axial DE Motor Vibration Spectrum

axial spectrum, in Figure 8, exhibits the highest amplitudes. It reaches nearly 10 mm/s, which is a distinct signature of angular misalignment. High axial vibration is widely recognized in the literature as a primary symptom of shafts not being collinear.
